Fort Smith Reservoir Intake Tower

Azo-Grout™ 424 by
Azon

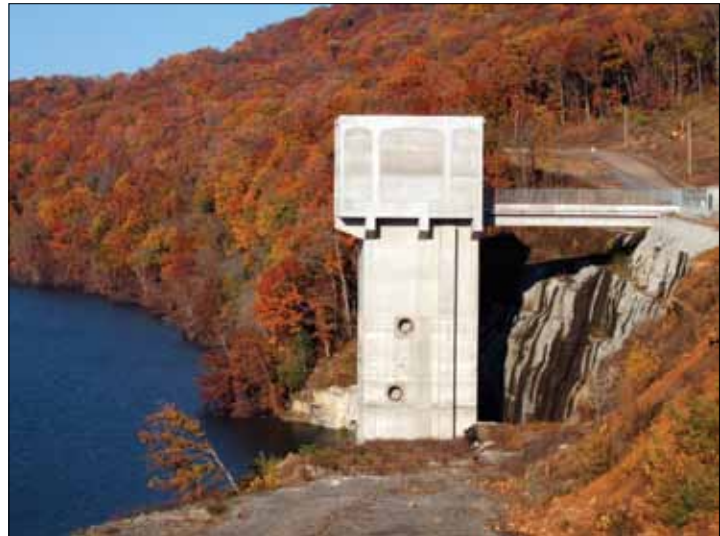
Figure 1 The concrete intake tower at Lake Fort Smith State Park.

The concrete intake tower for a new reservoir at Lake Fort Smith State Park was experiencing leakage at construction joints in the substructure.

As the water reservoir was filled, various leaks were occurring at different elevations, causing dampness and calcite to form inside the access well of the concrete structure.

Even though the substructure where the leaks formed was designed with double waterstops and walls more than 5 feet thick, water was bypassing the waterstops through various shrinkage cracks, including fractures and form tie holes adjacent to the horizontal construction joints.

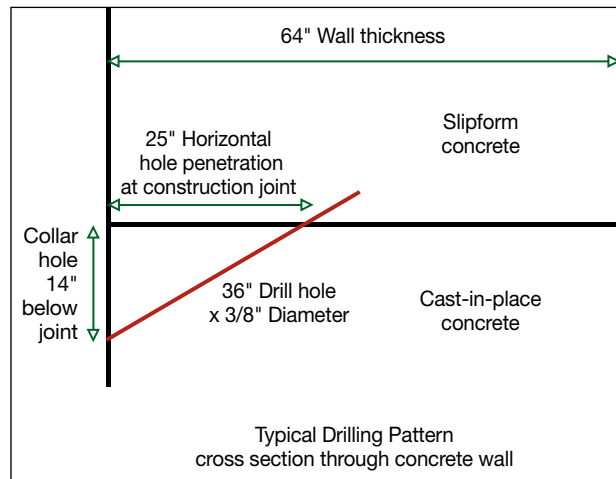
Figure 2 Sample diagram of injection holes.

- Holes were drilled 3/8 inches in diameter by 36 inches deep.
- The hole depth was achieved in three stages: 10 inches to 22 inches to 36 inches.

- Using a steel brake line, holes were flushed clean with water to remove any residual dust left after drilling the holes.
- Plastic injection packers were installed at the collar of each hole.
- A 5 percent phosphoric acid solution was injected to flush out the cracks and joints, followed by a flushing with clean water.

- Polyurethane was injected along the horizontal construction joints and principal cracks at a rate of 0.13 gallons per foot.
- Additional polyurethane was injected into the leaking form tie holes to prevent water from traveling through the wall at these locations.

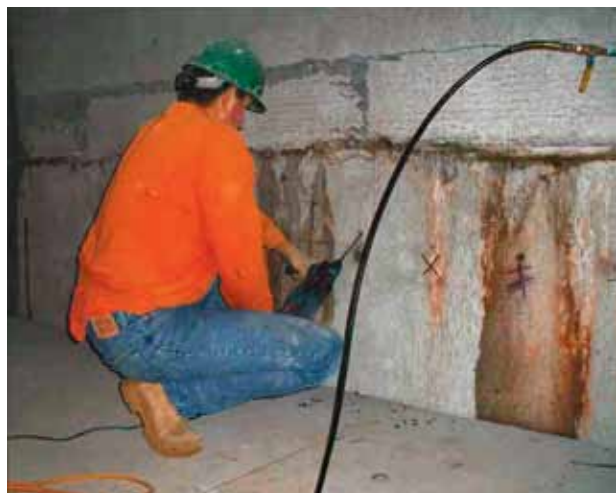
Figure 3 Drilling continues along the construction joint.

Step 1 Drilling injection holes
