**AzoGrout™**  
project folio

## Azo-Grout™ polyurethane waterstop products

# AzoGrout™

The project folio is a showcase of contemporary projects involving crack repairs in dams, reservoirs and manholes; deep soil stabilization excavations and void filling operations undertaken by our customers and contractors who use the full spectrum of products known as Azo-Grout™.

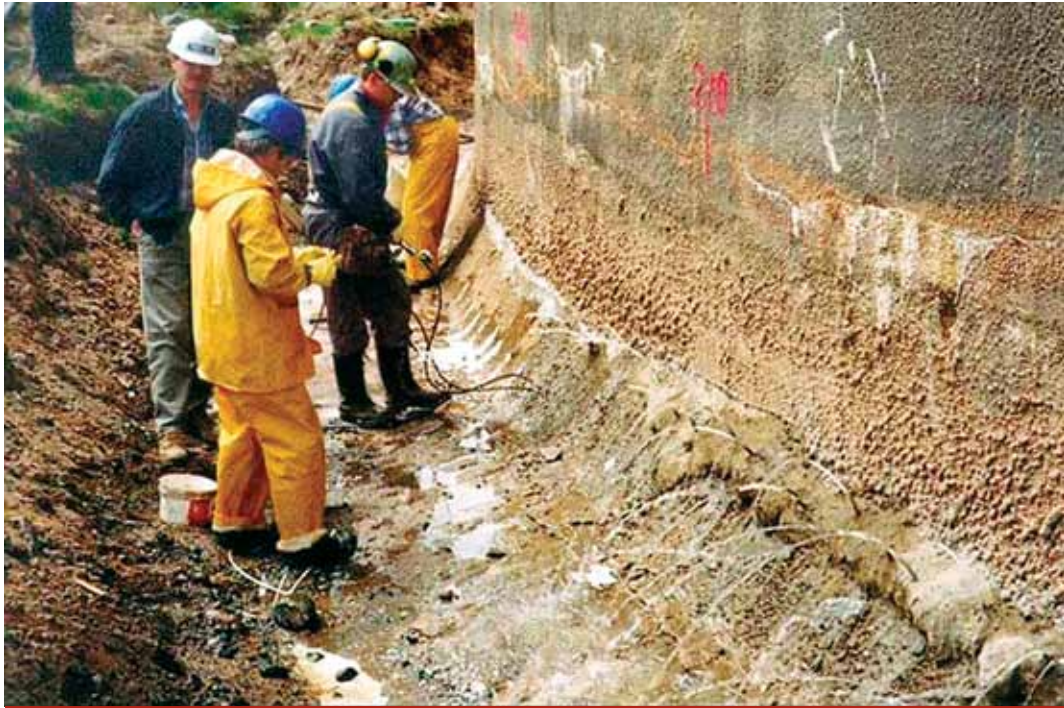
## Water tank construction joint sealing stops water leaks in cracks, joints and pipe seals | Azo-Grout™ 424

After several failed joint repairs at a water reservoir in Nova Scotia, the general contractor hired technical specialists from Multiurethanes to train his personnel in the use of special injection techniques to stop the leakage. Workers were finally able to seal off the tank's joints using Azo-Grout™ 424 and proper injection methods to create a dense, flexible foam joint seal.

<b>Project:</b>	Water tank repair
<b>Location:</b>	Dartmouth, Nova Scotia
<b>Distributor:</b>	Multiurethanes Ltd.
<b>Product used:</b>	Azo-Grout™ 424

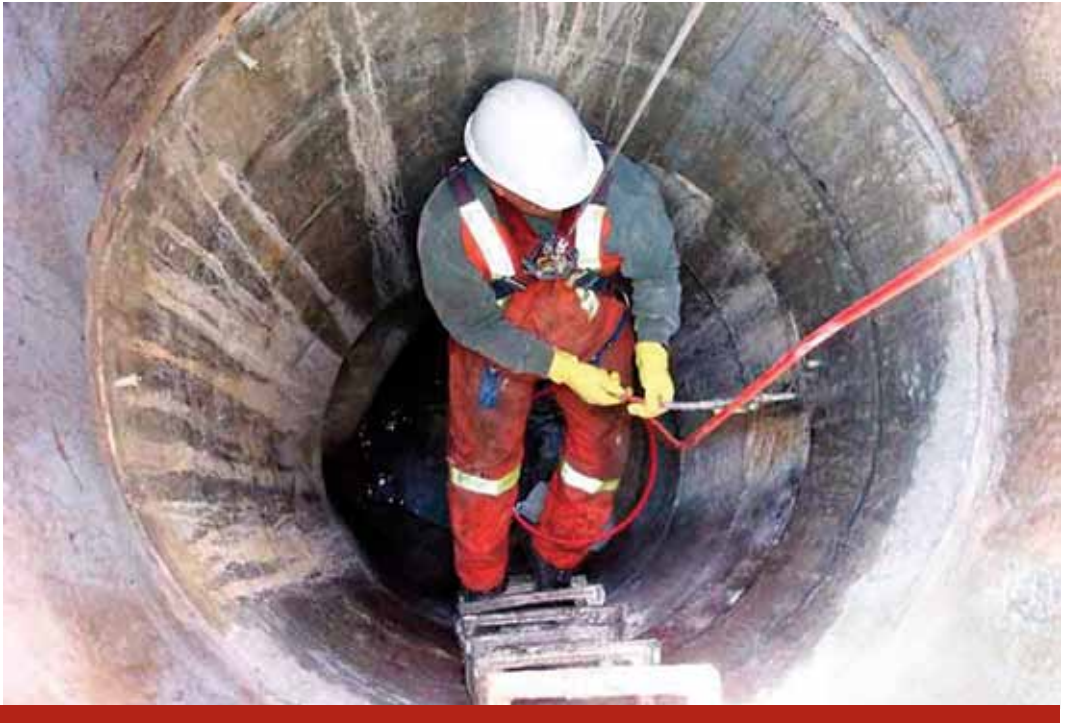
## Crack and joint sealing stops water flow in sewers and manholes | Azo-Grout™ 675

When a sewer pipe separated from a manhole structure, the sewer repair contractor took advantage of the soil stabilization properties of Azo-Grout™ 443 and the use of resin absorbent grout pads to stop a 50 gpm groundwater inflow. To solidify the manhole's pre-cast joints and prevent further seepage, contractors sealed the cracks with Azo-Grout™ 675.

■ <b>Project:</b>	Manhole repair
<b>Location:</b>	Waterford, Michigan
<b>General contractor:</b>	Liquiforce
<b>Distributor:</b>	Multisurethanes Inc.
<b>Product used:</b>	Azo-Grout™ 675

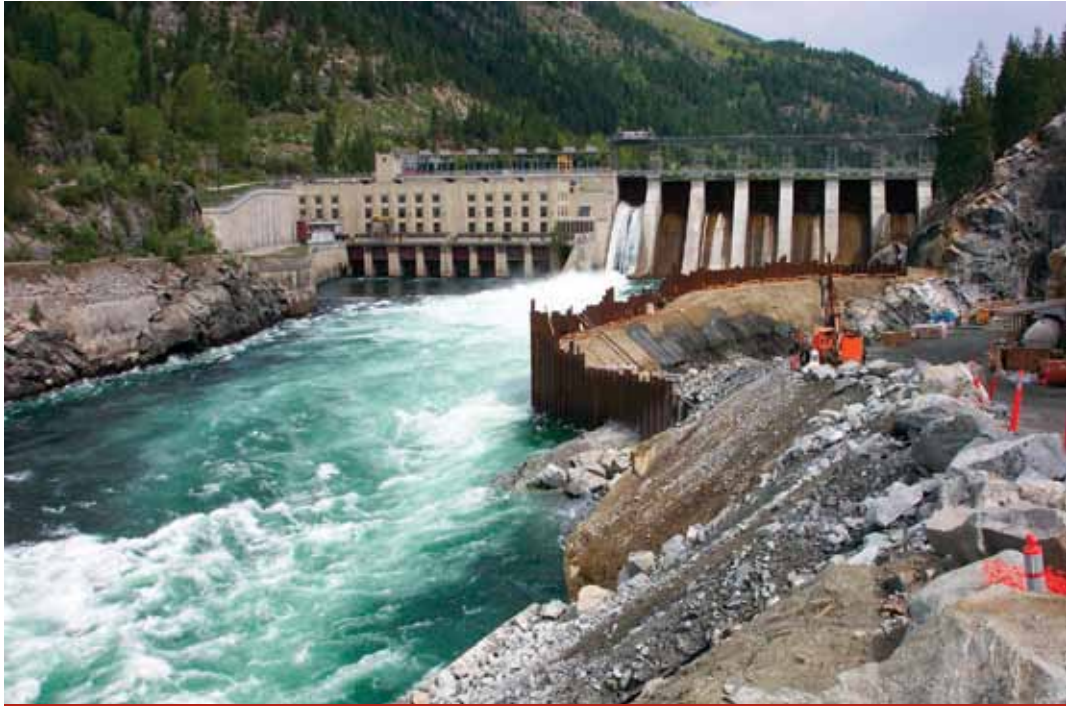
## Crack and joint sealing

stops water leaks in cracks, joints and pipe seals | **Azo-Grout™ 424**

The general contractor at the Brilliant Dam expansion project relied upon technical supervision from Multiurethanes to train his workforce in the appropriate methods for successfully injecting Azo-Grout™ 424 into large, gravity concrete, hydro-dam structures. The Azo-Grout formulation was used extensively to seal leaking cracks and construction joints.

<b>Project:</b>	Brilliant Dam repair
<b>Location:</b>	Castlegar, British Columbia
<b>General contractor:</b>	Hatch Energy
<b>Distributor:</b>	Multiurethanes Ltd.
<b>Product used:</b>	Azo-Grout™ 424

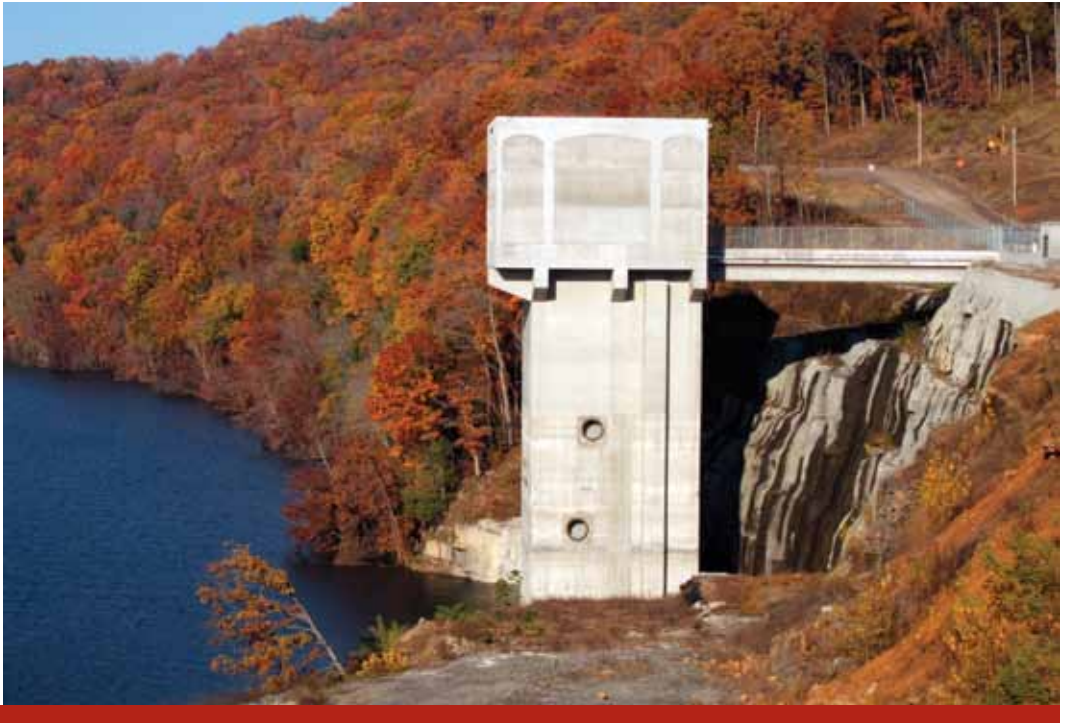
## Crack and joint sealing

stops water leaks in cracks, joints and pipe seals | **Azo-Grout™ 424**

The intake tower in a new dam at Lake Fort Smith State Park was designed with double waterstops and walls more than five feet thick. Yet, trouble arose as the reservoir was filling when water bypassed the waterstops through various shrinkage cracks. At a depth of more than 30 feet below the reservoir water level, the general contractor overcame the problem by using special injection equipment and deep-drilling techniques to pre-flush the shrinkage cracks and inject the powerful water cut-off system—Azo-Grout™ 424.

■ <b>Project:</b>	Lake Fort Smith intake tower
<b>Location:</b>	Mountainburg, Arkansas
<b>General contractors:</b>	Granite Construction, Inc.
<b>Engineering firm:</b>	Burns & McDonnell
<b>Distributor:</b>	Multiurethanes Inc.
<b>Product used:</b>	Azo-Grout™ 424

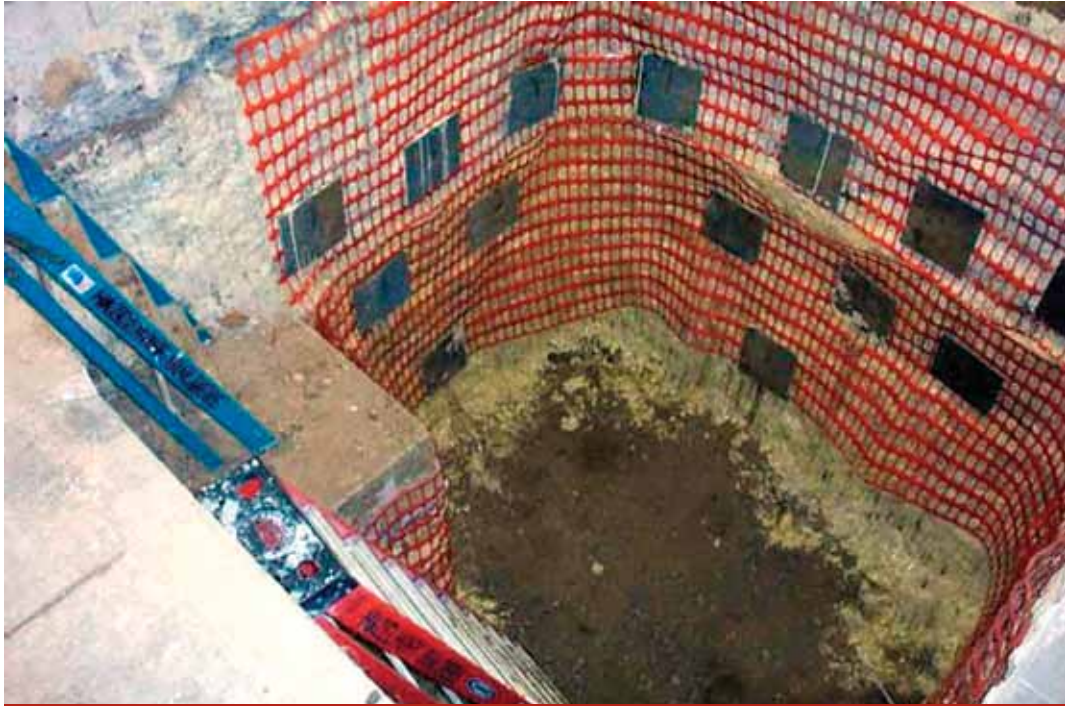
## Excavation soil stabilization prevents erosion and stabilizes soil | Azo-Grout™ 443

Facility managers at an Eaton manufacturing plant sought to construct new equipment foundations in close proximity to existing operating machinery. The construction would require deep excavation below the water table and through unconsolidated sand and gravel. To stabilize the soil perimeter prior to excavation, the general contractor chose to systematically inject Azo-Grout™ 443 through vertical sleeve pipes that were strategically placed around the planned excavation site.

<b>Project:</b>	Soil stabilization
<b>Location:</b>	Galesburg, Michigan
<b>General contractor:</b>	Hazelhoff Builders Inc.
<b>Distributor:</b>	Multisurethanes Inc.
<b>Product used:</b>	Azo-Grout™ 443

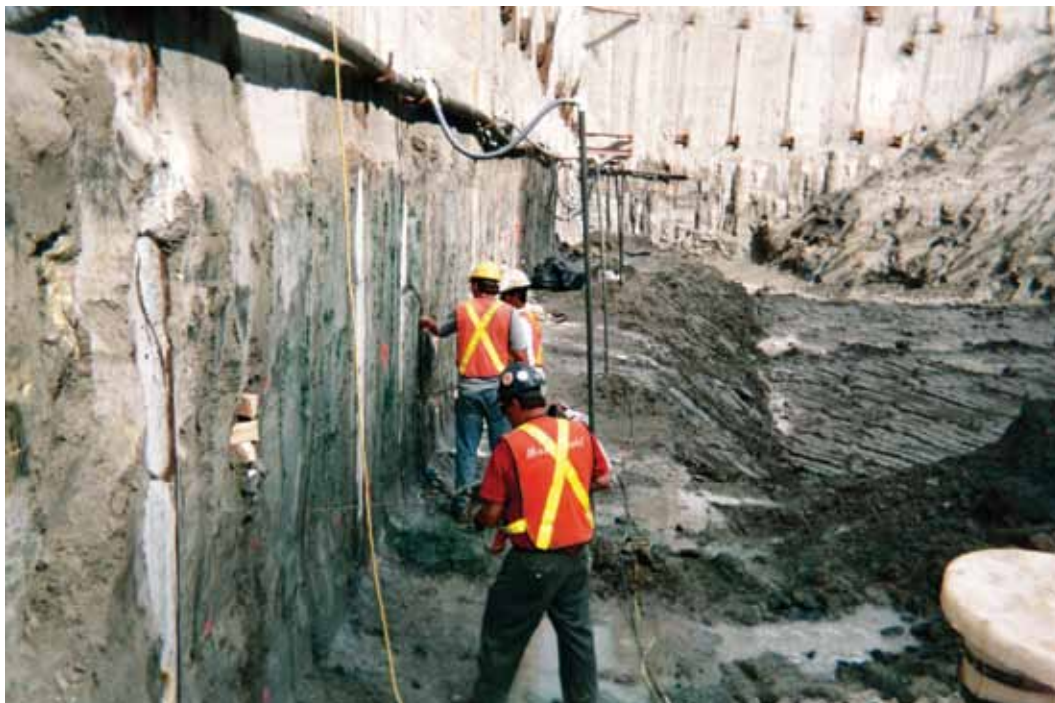
## Sealing caisson wall leaks stops water seepage into deep foundation excavations | Azo-Grout™ 443

Deep excavation contractors frequently encounter sub-surface water and soil inflow conditions when dealing with caisson walls and cable tieback anchors. On a major condominium construction site, the excavation contractor used Azo-Grout™ 443 to plug wall defects and prevent groundwater and quicksand from entering the excavation area.

■ <b>Project:</b>	Caisson walls
<b>Location:</b>	Oakville, Ontario
<b>General contractor:</b>	Rumble Foundation
<b>Distributor:</b>	Multiurethanes Ltd.
<b>Product used:</b>	Azo-Grout™ 443

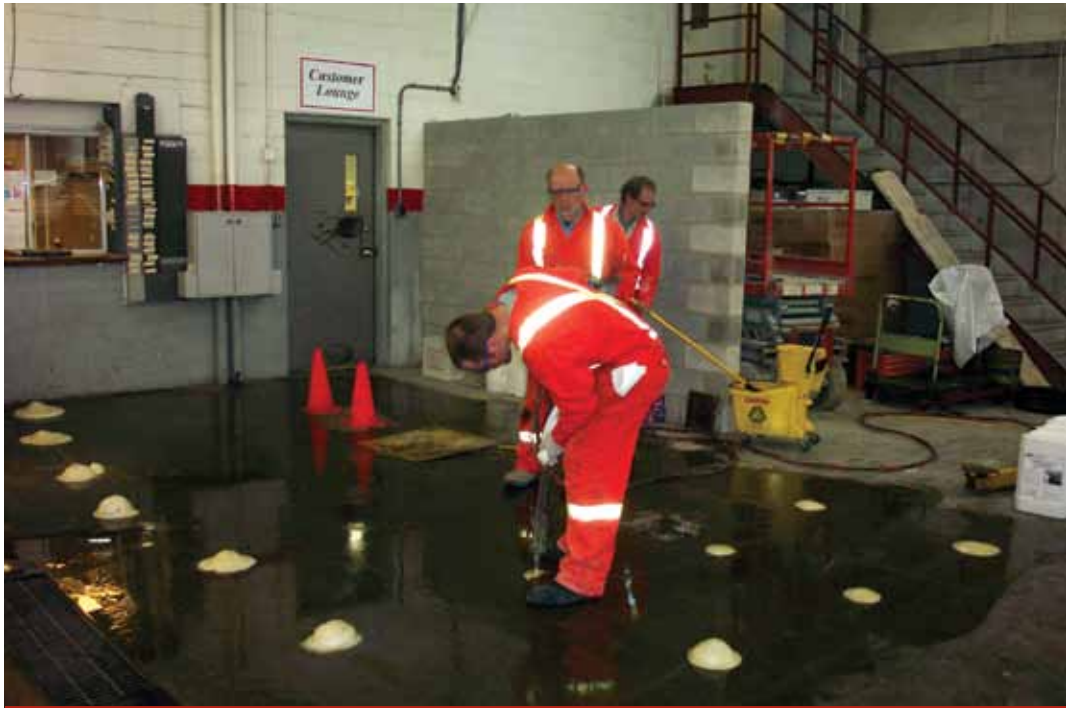
## Underground void filling slab lifting of floors, roadways and sidewalks | Azo-Grout™ 551

A busy car dealership was undergoing renovation and expansion when voids were discovered beneath the concrete floor in their service bays. Azo-Grout™ 551 was injected through strategically drilled holes to fill the voids and provide support to the concrete floor slabs.

■ <b>Project:</b>	<b>Void filling</b>
<b>Location:</b>	<b>Mississauga, Ontario</b>
<b>Distributor:</b>	<b>Multisurethanes Ltd.</b>
<b>Product used:</b>	<b>Azo-Grout™ 551</b>
